Subj: COMMAND INVESTIGATION INTO THE CIRCUMSTANCES REGARDING THE  
FIRE ONBOARD USS OSCAR AUSTIN (DDG 79) ON 10 NOV 18

Subj: COMMAND INVESTIGATION INTO THE CIRCUMSTANCES REGARDING  
THE FIRE ONBOARD USS OSCAR AUSTIN (DDG 79) ON 10 NOV 2018

**(Origin, Cause, & Fire Spread)**

USS OSCAR AUSTIN (DDG 79) FIRE INVESTIGATION INTERIM REPORT

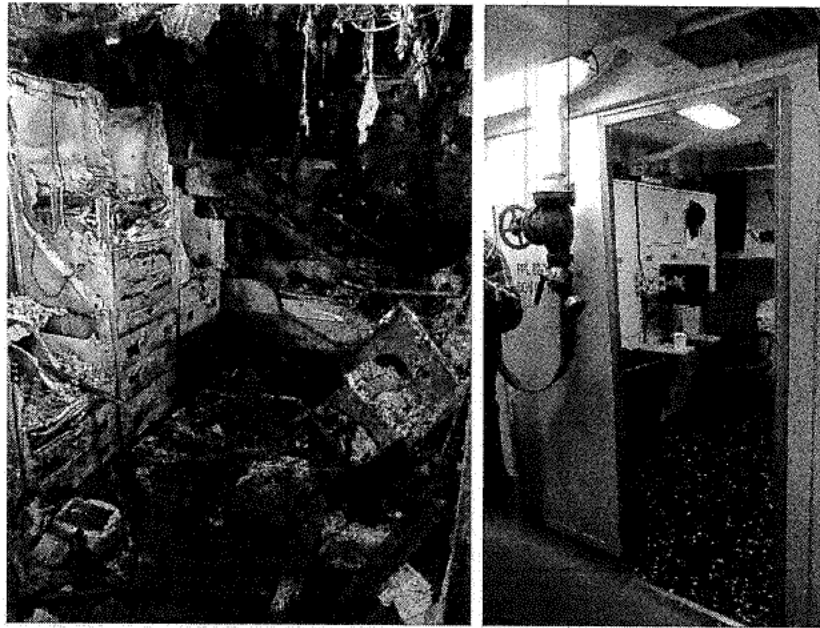
Figure 1 – Compartment of Fire Origin  
DDG 79 Stateroom (b)(3),10USC130 (Left) & DDG 81 Exemplary Stateroom (b)(3),10USC130 (Right)

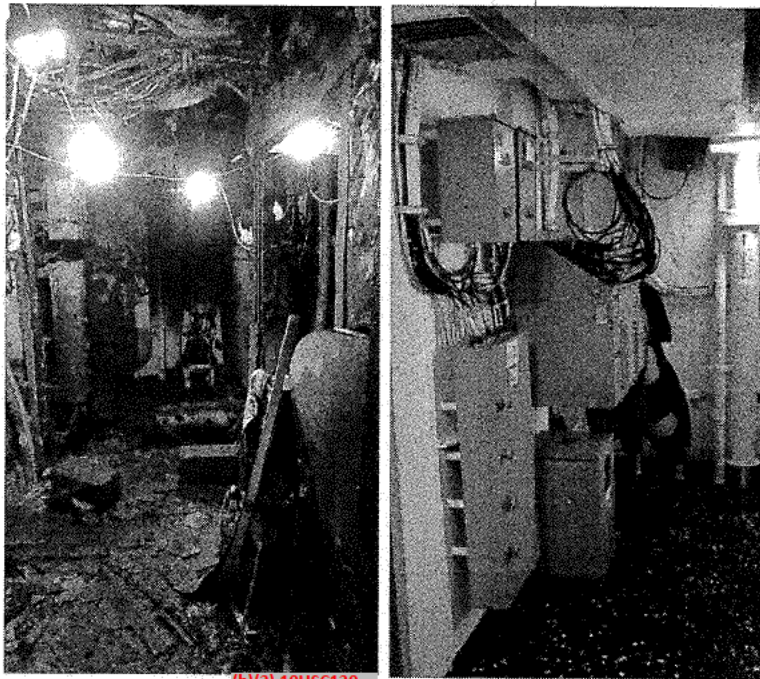
Figure 2 – Passage (b)(3),10USC130 DDG 79 (Left) and DDG 81 (Right).

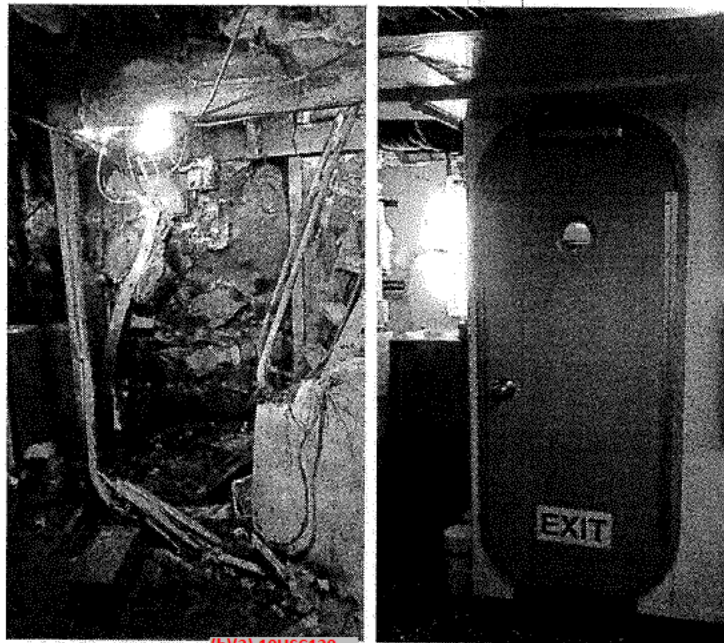
Figure 3 – Passage (b)(3),10USC130 DDG 79 (Left) and DDG 81 (Right).

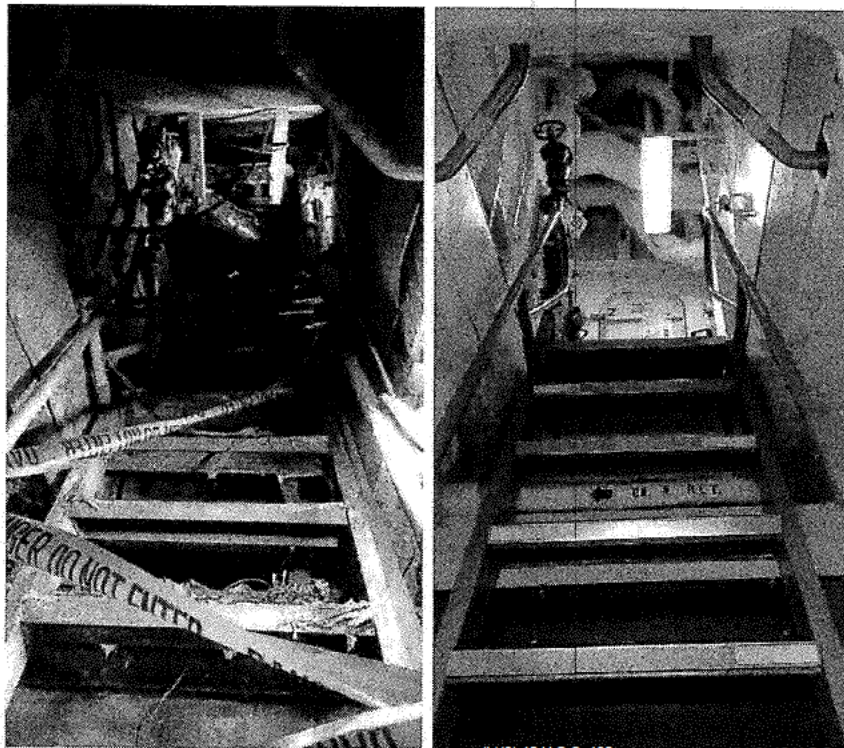
Figure 4 – View up ladder to 03 Level; Passage (b)(3) 10 U.S.C. 130 to Passage (b)(3) 10 U.S.C. 130  
DDG 79 (Left) and DDG 81 (Right)

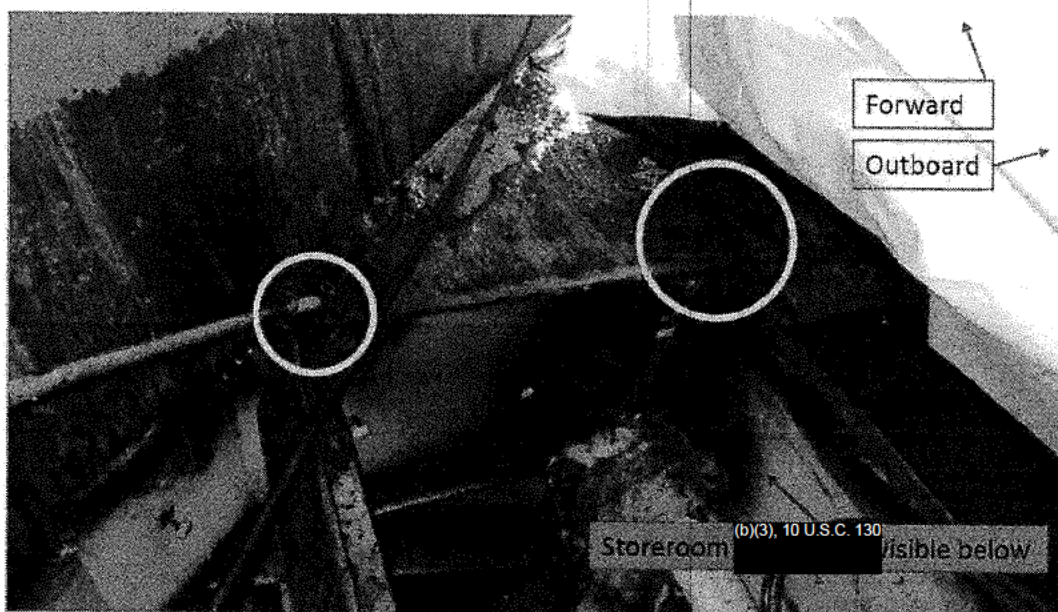
The ignition/heat source for this fire was direct torch contact or hot slag from the oxygen-natural gas torch cutting being conducted above the area of the Officer Baggage Storeroom, aka Computer Storeroom (b)(3), 10 USC 130. Figure 5 shows the location of the cutting area on the 03 Weather deck. The cutting operations extended beyond the boundaries of (b)(3), 10 USC 130 to include Stateroom (b)(3), 10 USC 130 which was not intended to be affected, and, as such did not have a fire watch. After contacting combustibles in the stateroom, torch flame and/or hot slag started a Class ALPHA fire. Over the course of the incident, the fire grew, engulfing the stateroom and spreading through the open stateroom door, eventually causing complete destruction of the non-metallic joiner bulkhead that separates Stateroom (b)(3), 10 USC 130 and Passage (b)(3), 10 USC 130. The fire spread throughout this passageway and further into the 02 level both FWD and AFT. The fire also spread through an open door into and up the adjoining Ladderway (b)(3), 10 USC 130 which resulted in fire spreading to the 03 level and, in time, completely compromised the non-metallic joiner bulkheads separating the Passage from the Ladderway on the 02 level. Figures 6 and 7 show the primary areas of fire damage (where flaming combustion occurred) on the 02 and 03 levels. In addition, many additional spaces on the 02, 03, and 04 levels suffered varying degrees of heat, smoke, and water damage. No visible damage was observed on the 01 level directly underneath the compartment of fire origin or its adjacent compartments. Appendix C contains general arrangement drawings for the 01 to 04 levels in the vicinity of the casualty.

Figure 5 – 03 Weather Deck Torch cuts

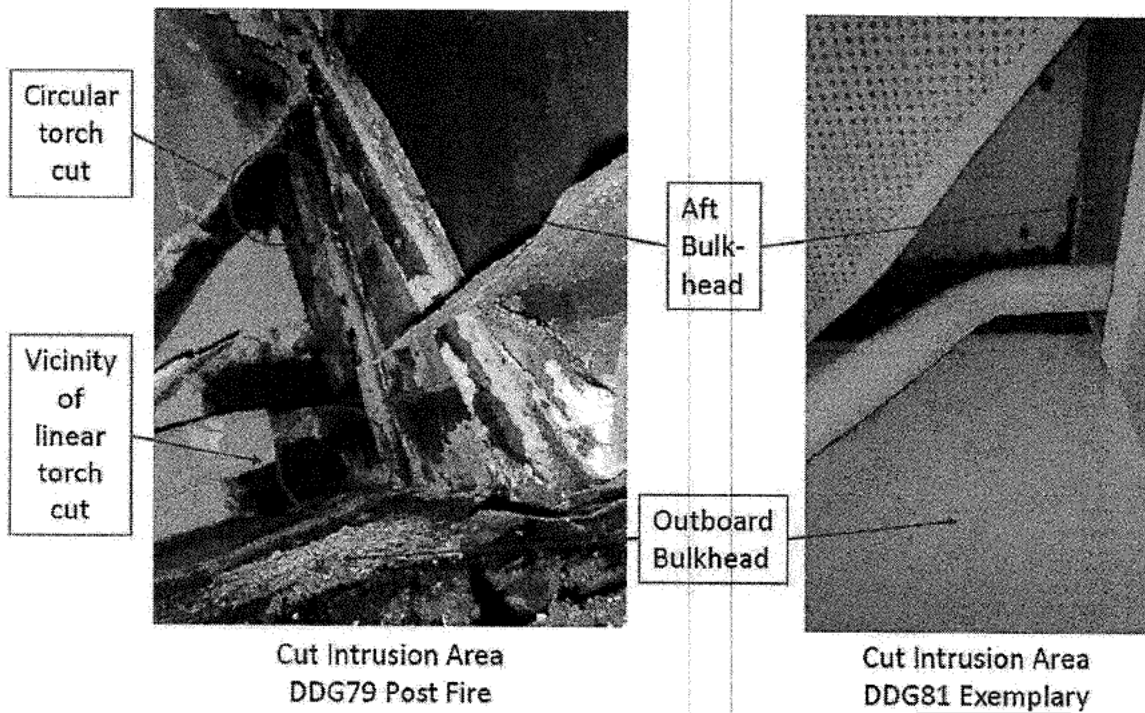
The location of the torch cuts in the overhead of (b)(3),10USC130 (Figure 8), the proximity of the torch cut area to the bunk (Figure 9), the appearance of remaining combustibles, and the intensity of damage to aluminum stateroom furniture (Figure 10) indicate that the point of origin was located in the AFT/STBD (Outboard) corner of the Stateroom. It is difficult to state for certain if the first fuel ignited was bulkhead insulation located high in this area or on the bunk itself (fabric spring cover or printer located on lower bunk). However, damage evidence indicates that a significant radiant source existed on the Aft portion of the bottom bunk in the early stages of the fire. Please see the following section for additional discussion on the cause.

Figure 8 – Torch Cut Locations in Notched Portion of Overhead in Stateroom (b)(3),10USC130

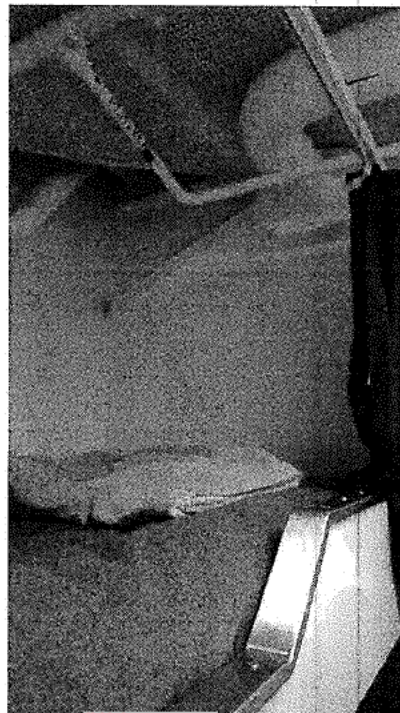
Figure 9 – Notched Portion of (b)(3),10USC130 Overhead above Bunk; DDG 81 Exemplary

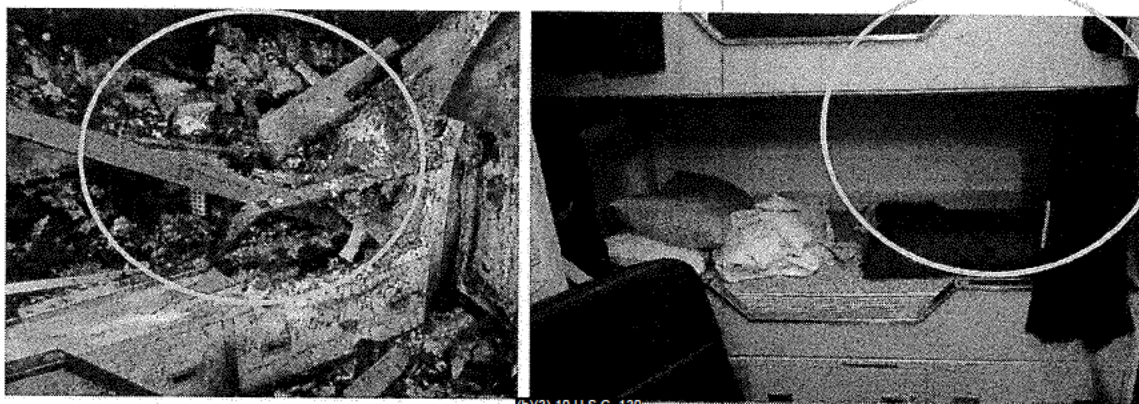
Figure 10 – Aft Outboard corner of (b)(3) 10 U.S.C. 130 DDG 79 (Left) and DDG 81 (Right).

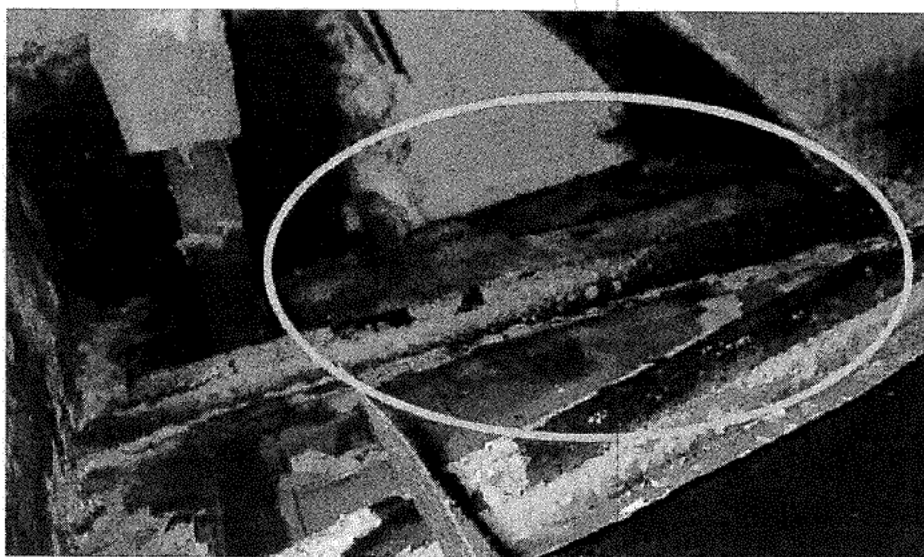
was recovered on the horizontal bulkhead angle just below the burned hole (Figure 11). Natural gas/oxygen torch flames capable of burning through steel are generally in excess of 2700°C (reference (f)). Contact of such with the bulkhead foam-type insulation would have resulted in its ignition. Figure 15 depicts combusted bulkhead insulation in the area below where the hole was burned through. The reported black smoke, typically associated with a fire involving a hydro-carbon based material, is indicative of the bulkhead foam material being ignited. Once the bulkhead insulation was involved it could have spread to the insulation around the pipe seen in Figure 11. In addition, molten slag could have easily fallen onto the top or bottom bunk cover after spattering off the bulkhead angle. Slag is generally in excess of the 700°C minimum oxy-fuel cutting steel "kindling/ignition" temperature (reference (f)). The auto-ignition temperature of cotton is in the range of 255-400°C (reference (g)). Therefore, slag coming in contact with the thermally thin cotton duck cover would have likely resulted in the cover's ignition. If this were the bottom bunk cover, it would have spread to the printer early in the event, also producing dark smoke.

Figure 11 – Looking Up Above (b)(3),10USC130 Bunk Area Showing Location of Bulkhead Insulation and Structural Angles Below Location of Burned Hole in Deck.

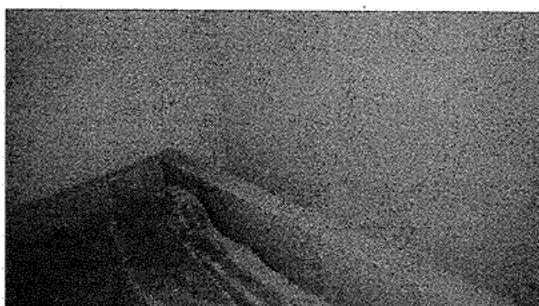
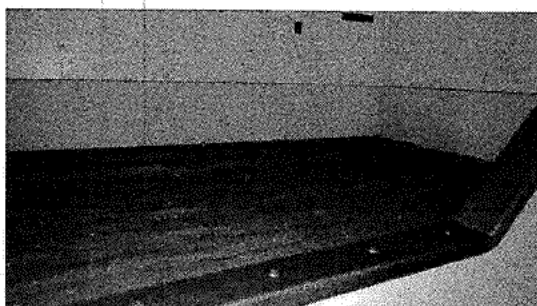
Figure 12 – (Left) Bunk Assembly Located Approximately 3" Forward of Burned Hole at Top of Bulkhead (DDG 81 Exemplar Stateroom).

(Right) Exemplar Cotton Duck Spring Cover on Bunk (DDG 79 Stateroom)

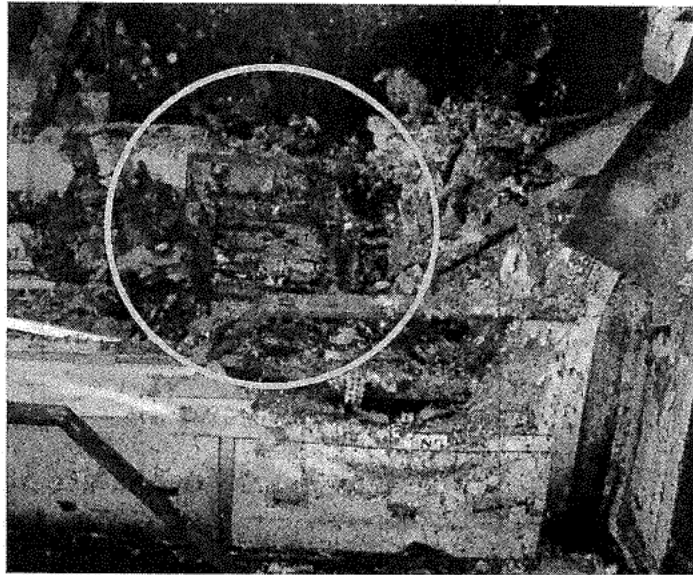
Figure 13 –Printer Remains Recovered on Lower Bunk in (b)(3), 10 USC 130

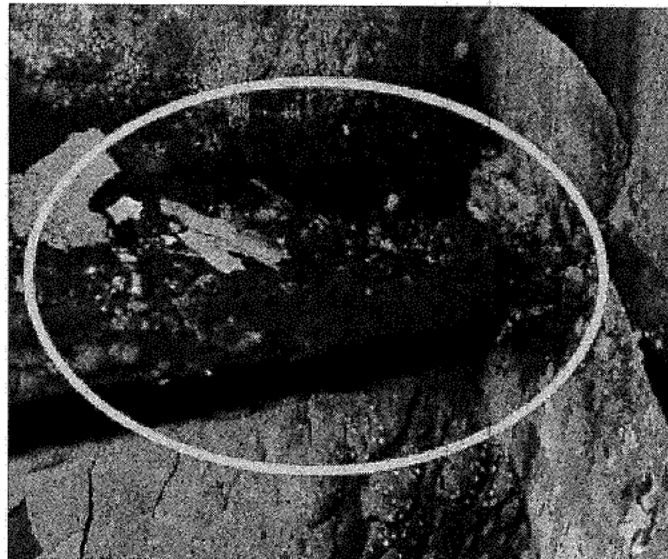
(39) Evidence of the slag was found by the NAVSEA 05 investigators on the bulkhead inside the stateroom. This slag is the likely ignition source. [encl 2]

Figure 14 –Slag from Burning of Hole Found on Angle Below Hole in (b)(3), 10 USC 130

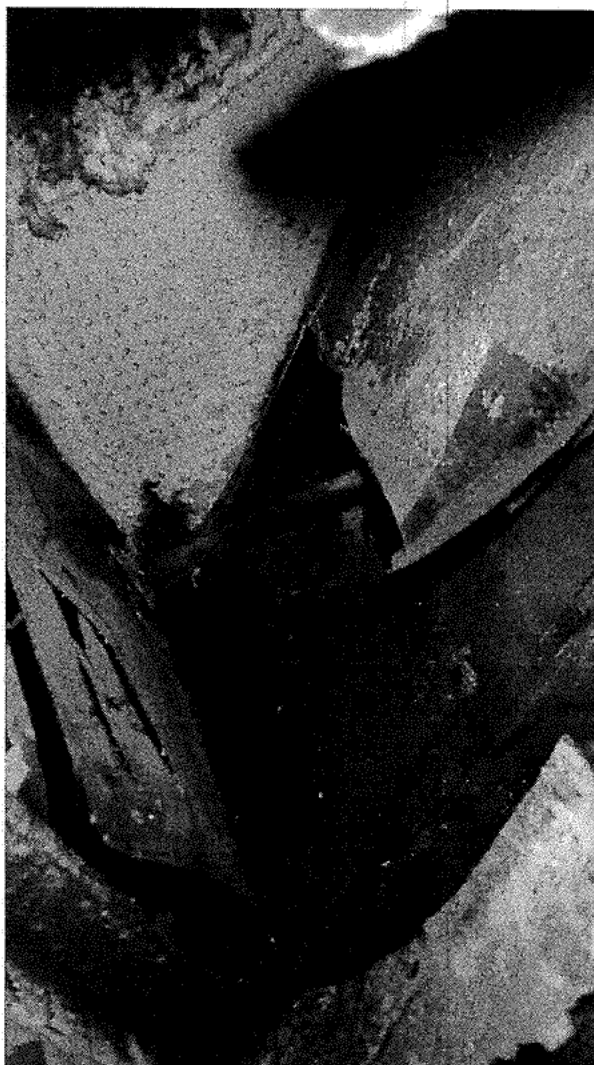
**Figure 15 –Combusted Bulkhead Insulation in the Area of the Hole Burned through the Overhead of (b)(3),10USC130 (orange dowel inserted through the hole for clarity of location).**

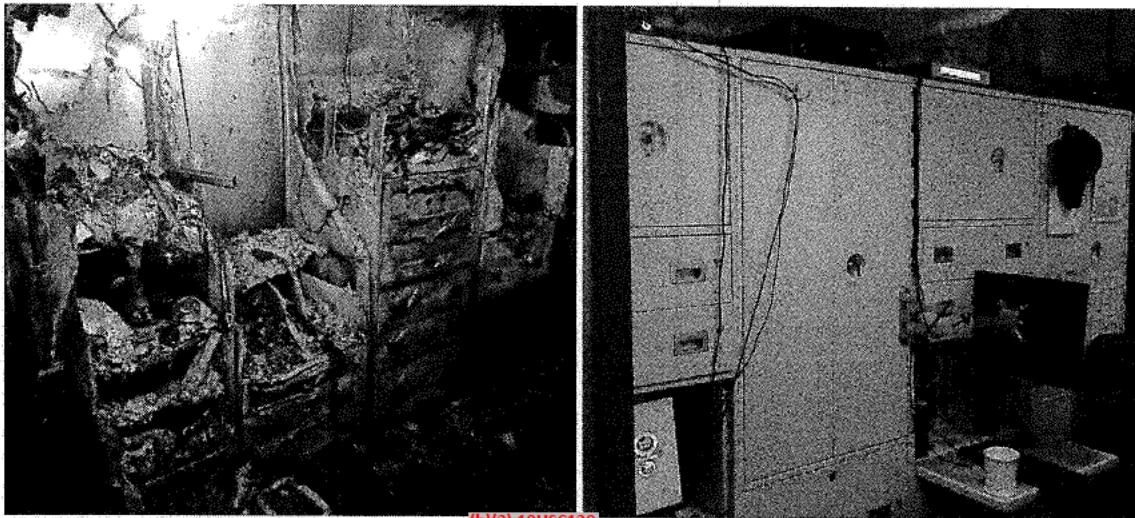
Figure 16 – Forward Bulkhead (b)(3),10USC130 /view, DDG 79 (Left) and DDG 81 (Right)

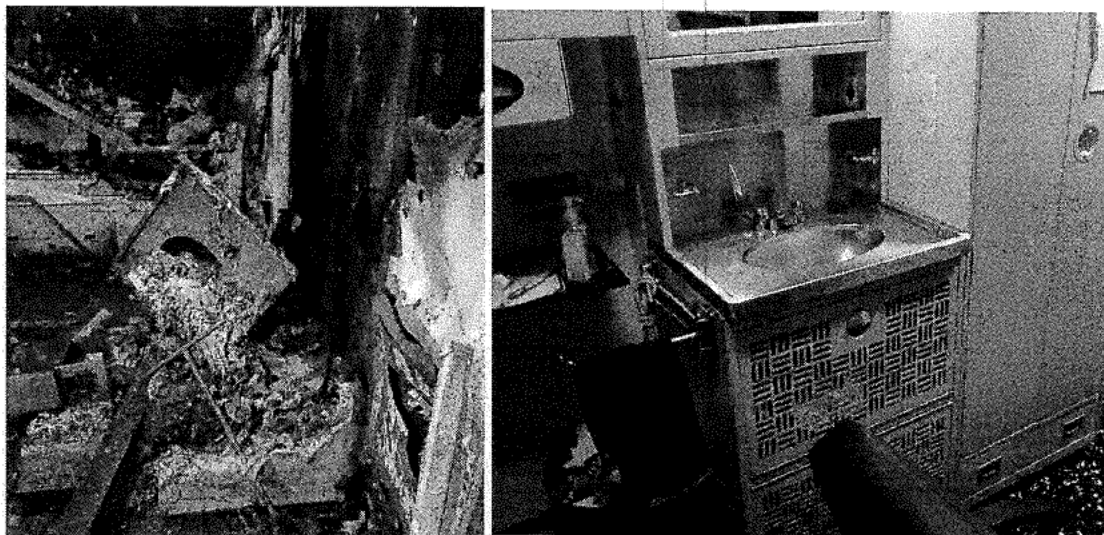
Figure 17 – Aft Bulkhead (b)(3),10USC130 /view, DDG 79 (Left) and DDG 81 (Right)

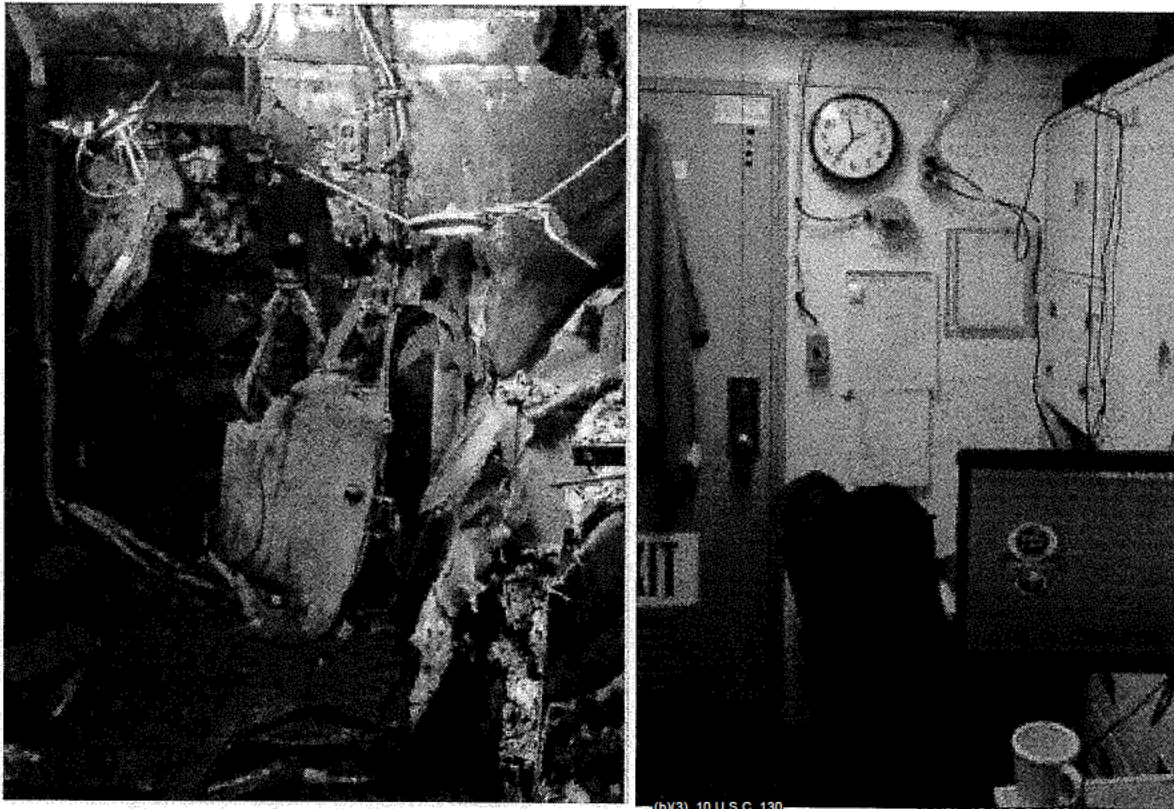
As fire involving the bunk area became fully developed, fire spread up the AFT/Outboard corner of the compartment to engage the overhead. At this point the fire became hot enough to cause significant structural failure of the aluminum bunk furniture, eventually causing structural collapse of the Aft end of the upper bunk, and causing significant panel holing of the Aft end of the bottom bunk. As the compartment heated, it is anticipated that other combustibles on the bulkheads and in the overhead became involved, such as the bulkhead, duct, and pipe insulation as well as the limited amount of cabling present. As the compartment became fully involved, it caused the structural collapse of the aluminum compartment cabinetry (Figures 16 and 17) and complete destruction of the non-metallic joiner bulkhead separating the stateroom from Passage (b)(3),10USC130 Figure 18).

Figure 18 – Inboard Bulkhead between Stateroom (b)(3), 10 U.S.C. 130 and Passage (b)(3), 10 U.S.C. 130 Fire Destroyed on DDG 79 (Left) and DDG 81 Exemplar (Right)

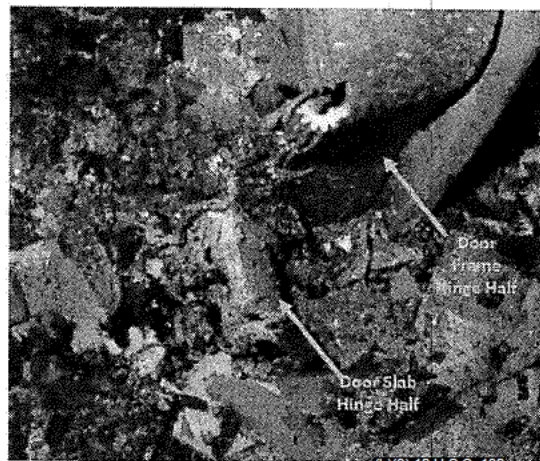
Figure 19 shows the remains of the stateroom door hinge halves, looking from above. This photo shows the door slab hinge half (edge of door) remains are at approximately a 90-degree angle with the door frame hinge half remains. The remains of the cipher lock were also found on the deck against the aft bulkhead. This indicates the door was open during the fire, which would have enabled smoke and fire to spread from the stateroom to Passage (b)(3), 10 U.S.C. 130 even prior to the failure of the stateroom bulkhead. As the fire exited the stateroom, it spread into the overhead of Passage (b)(3), 10 U.S.C. 130. The heat in the overhead of (b)(3), 10 U.S.C. 130 and (b)(3), 10 U.S.C. 130 was so significant that aluminum HVAC ductwork in these areas completely melted and collapsed (Figure 20).

Figure 19 – Looking from Above. Remains of Stateroom (b)(3), 10 U.S.C. 130 Entry Door Hinge Halves.

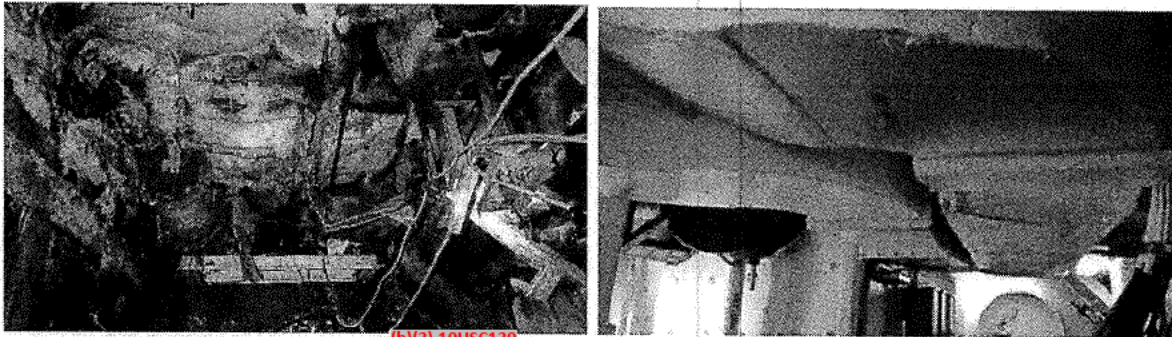
Figure 20 – Passage (b)(3), 10 USC 130 Looking Forward at Missing Overhead Ductwork DDG 79 (Left) and DDG 81 (Right)

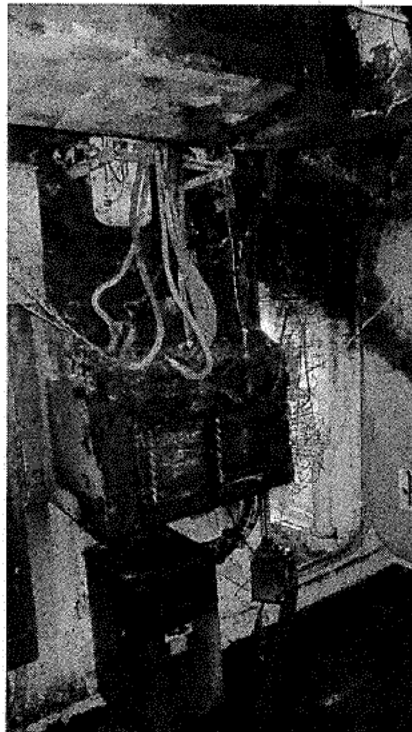
The fire, now in the passage, was supplied with ample air flow from multiple directions due to most doors in the area being open. Aft of the Stateroom and outboard of passage (b)(3), 10 USC 130 an open door between passages (b)(3), 10 USC 130 and (b)(3), 10 USC 130 Figure 21), allowed access to ventilation from a ladderway and a natural ventilation duct at the outboard end of Passage (b)(3), 10 USC 130 which drew the fire outboard down this passage. Forward of the stateroom, significant oxygen was available from open compartments and passages in O-country, which drew the fire in that direction also. The door to Passage (b)(3), 10 USC 130 (ladderway outside the Stateroom), was open during the fire, as evidenced by the presence of temporary service remains in the doorway and early reports of smoke on the 03 level from the (b)(3), 10 USC 130 firewatch (reference (h)). This open door provided access for the fire to spread up the ladder to the 03 level. A significant deck cut through the overhead of (b)(3), 10 USC 130 allowing airflow to the 04 level Pilot house area, drew the fire in that direction through intervening doors that were open (or removed) during the fire.

Figure 21 – View Aft from Passage (b)(3), 10 USC 130 through Open Door to Passage (b)(3), 10 USC 130

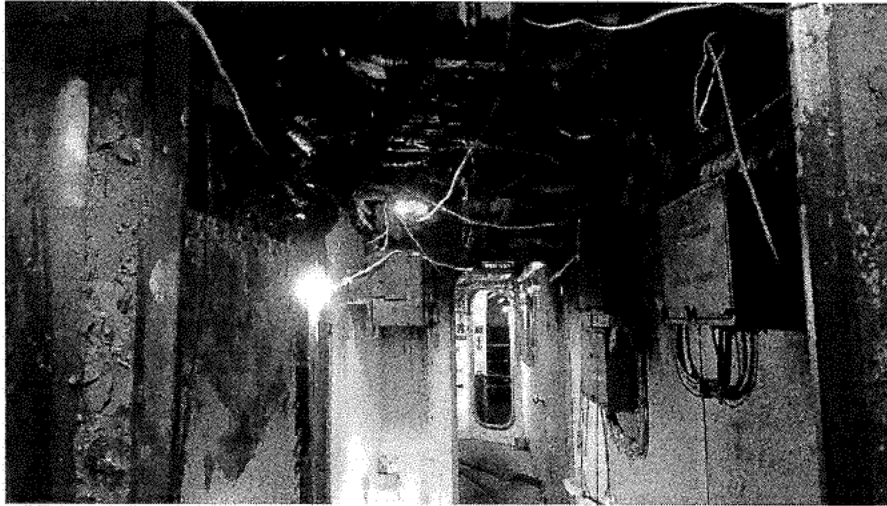
The fire spread forward from Passage (b)(3),10USC130 into Passage (b)(3),10USC130 unabated as the door between the Passages had been removed. Significant damage occurred to the electrical cabling and ductwork in the overhead of Passage (b)(3),10USC130 from fire and heat exposure (Figures 22 and 23). Impact to inboard Passage (b)(3),10USC130 and the other staterooms accessed via Passage (b)(3),10USC130 was primarily limited to smoke and/or water damage (Figures 24 and 25). *(Reserved for comment regarding possible chlorides from cable combustion)*

Figure 22 – Overhead Damage in Passage Overhead Looking Inboard  
from (b)(3),10USC130 to (b)(3),10USC130 and (b)(3),10USC130

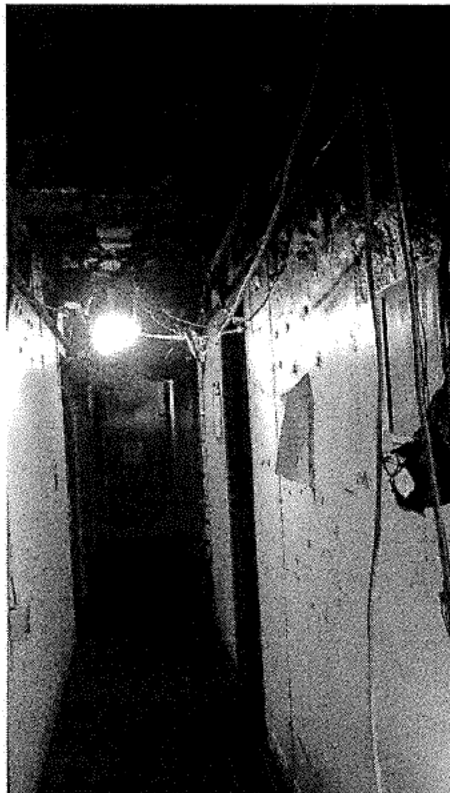
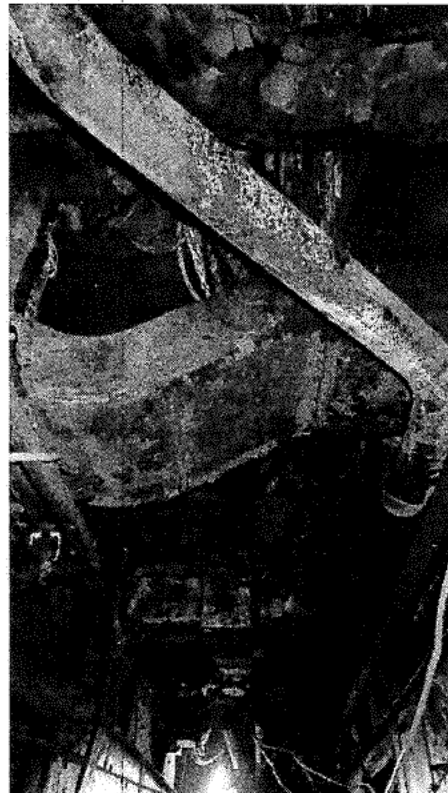
Figure 23 – Overhead Damage in Passage (b)(3),10USC130 Overhead Looking FWD towards Female Head

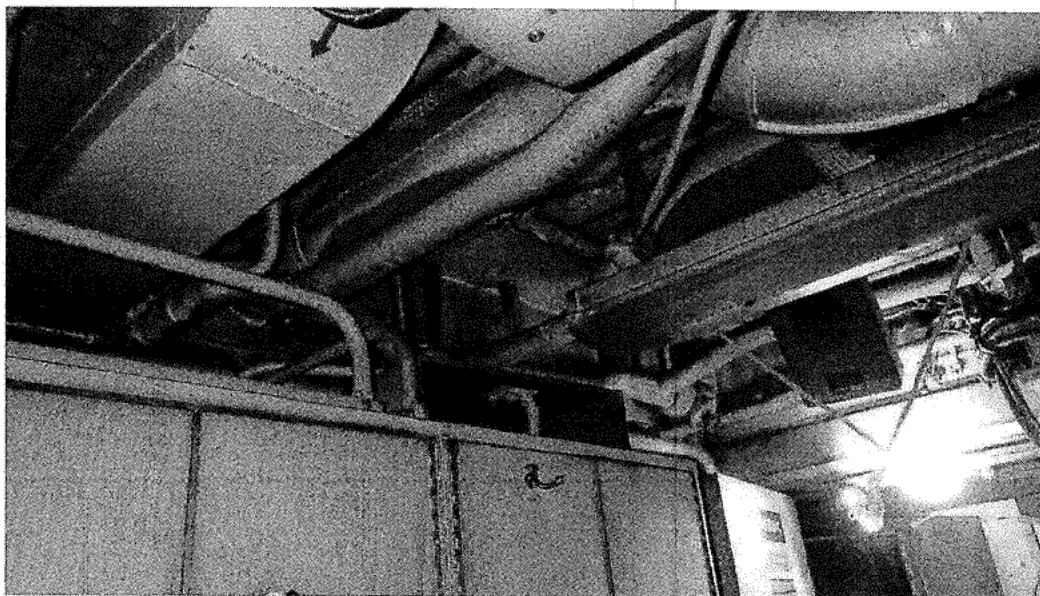
Figure 24 – Overhead Smoke Damage Typical of Staterooms off Passage (b)(3),10USC130

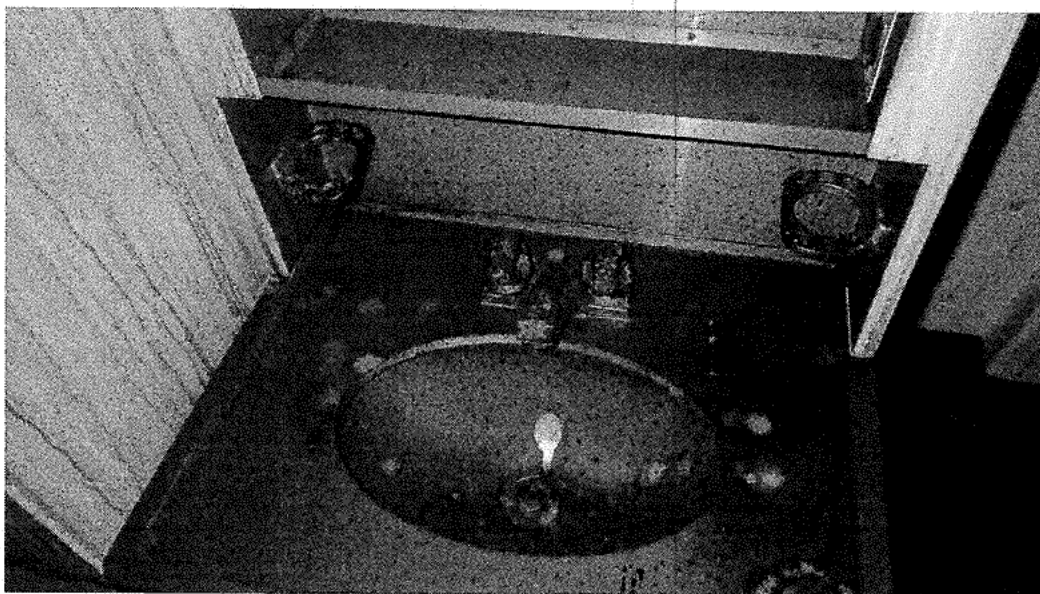
Figure 25 – Corrosion to CRES Sink in Stateroom (b)(3),10USC130 Door was Open During Fire)

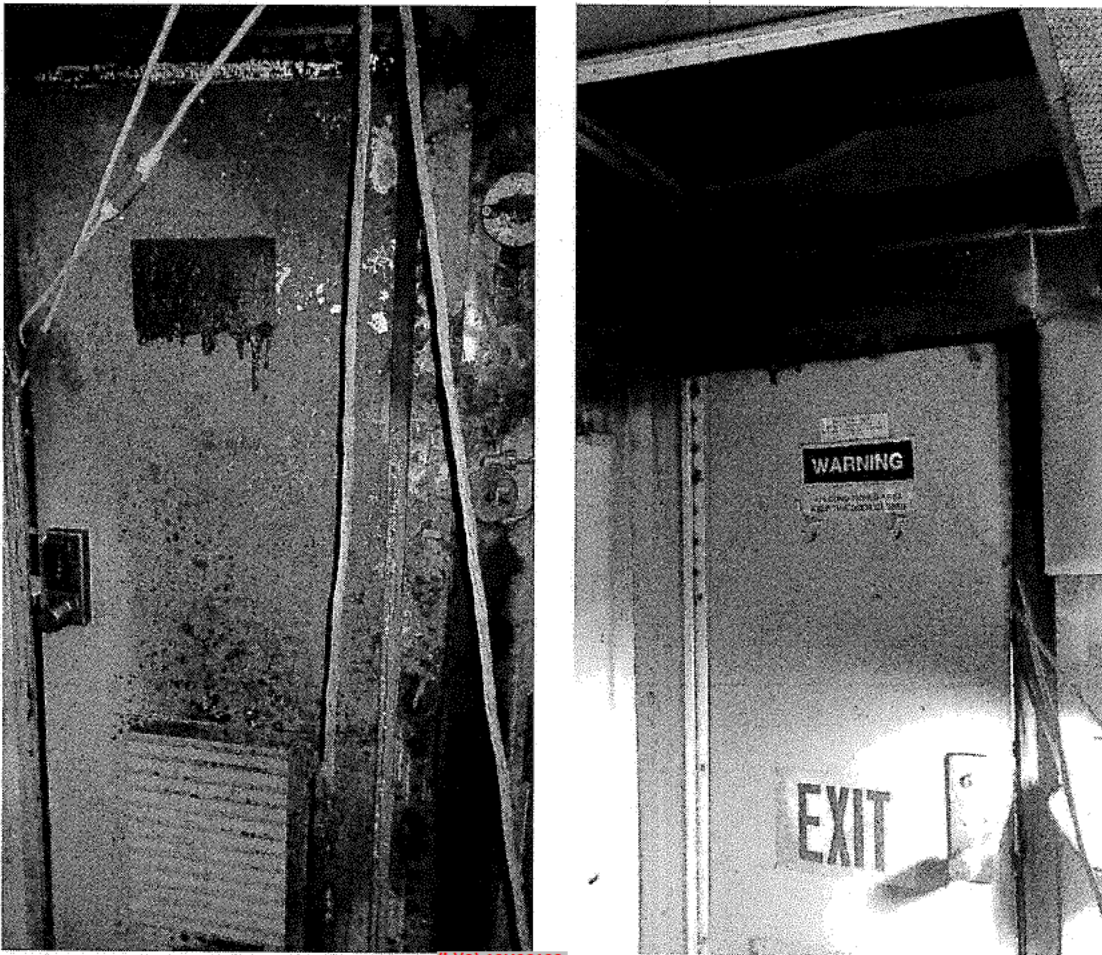
The Commanding Officer's Cabin (b)(3),10USC130 which is off the FWD end to the outboard of Passageway (b)(3),10USC130 sustained smoke damage throughout, but only minor fire damage around the top of the doorway despite the heavy fire in the passageway. Based on the presence of and damage to a temporary lighting cable running through the doorway, as well as the burn/damage pattern on the door itself, it is believed the CO Cabin door was only slightly ajar (to accommodate the lighting cable) during the fire, thus limiting damage to the cabin (Figures 26 and 27).

Figure 26 – Fire Damage to CO's Cabin Door (b)(3),10USC130 Passageway-side (Left). Only Minor Fire Extension into CO's Cabin Above Door which was Believed to be Only Partially Ajar During Fire (Right).

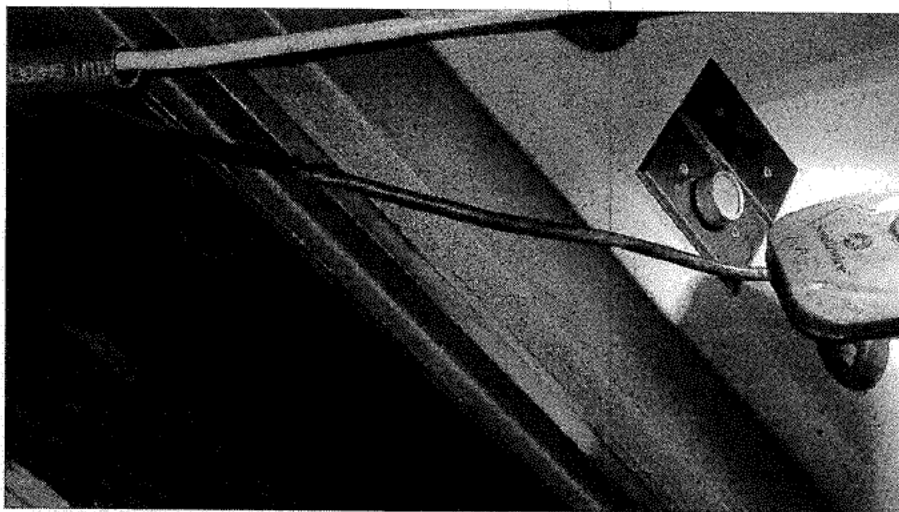
Figure 27 – Temporary Lighting Cable Running Past CO's Cabin (b) Door Jam. (3) 10USC130 Damage Pattern to Cable Indicates Door was Only Partially Ajar During Fire.

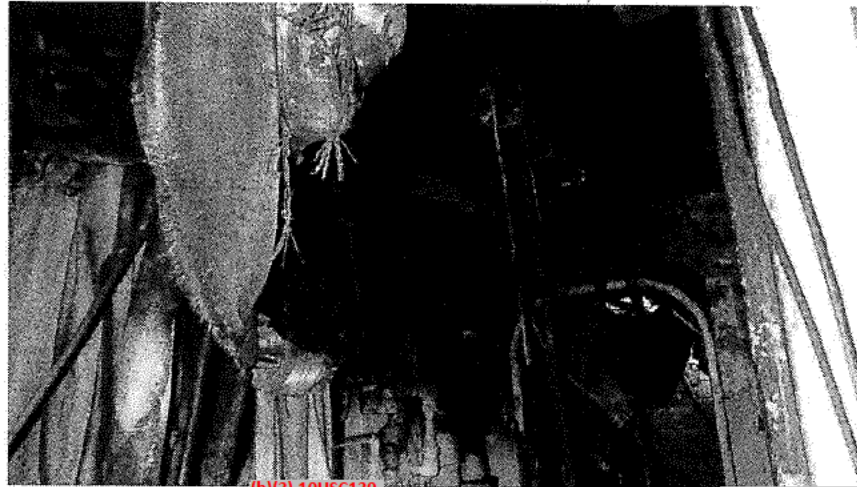
The fire moved AFT from Passage (b)(3),10USC130 and was primarily confined to Passage (b)(3),10USC130. Fire damage in Passage (b)(3),10USC130 primarily impacted cabling and ductwork located in the overhead (Figure 28). Impact to the storeroom and locker (b)(3),10USC130 and (b)(3),10USC130 located off Passage (b)(3),10USC130 was primarily heat, smoke and, and water damage. However, the forward bulkhead of the storeroom and locker was shared with the primary fire compartment (b)(3),10USC130 and exhibits substantial fire/heat damage to the non-metallic joiner bulkhead.

Figure 28 – Passage (b)(3),10USC130 Looking Inboard towards Passage (b)(3),10USC130

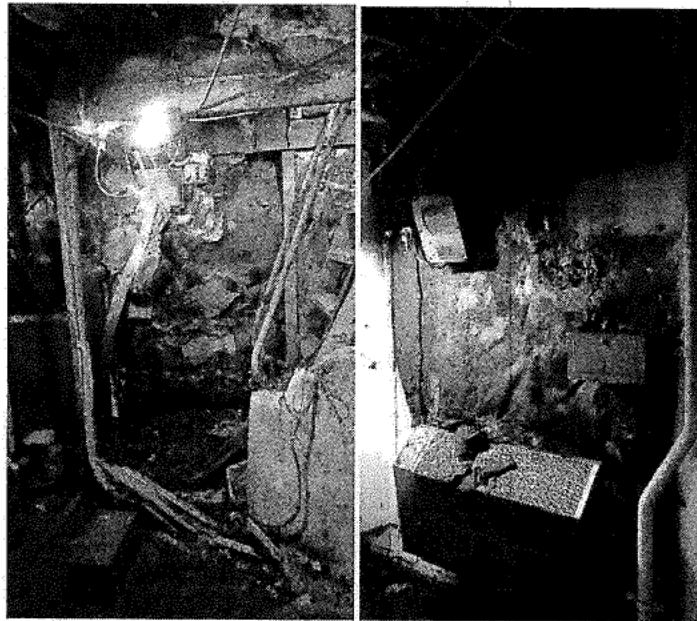
The fire moved inboard from Passage (b)(3),10USC130 into Passage (b)(3),10USC130 and upward via the ladderway (Figure 4) into Passage (b)(3),10USC130. The fire was so intense in Passage (b)(3),10USC130 that the non-metallic joiner bulkhead between Passages (b)(3),10USC130 and (b)(3),10USC130 was eventually completely destroyed (Figure 3). The non-metallic joiner bulkhead between Passage (b)(3),10USC130 and Officer's Head (b)(3),10USC130 was severely compromised, with some minor fire occurring in the Head (Figure 29).

Figure 29 - Compromised Non-Metallic Joiner Bulkhead  
Outboard Side (L) in Passage (b)(3),10USC130 Inboard Side (R) in Officer's Head (b)(3),10USC130

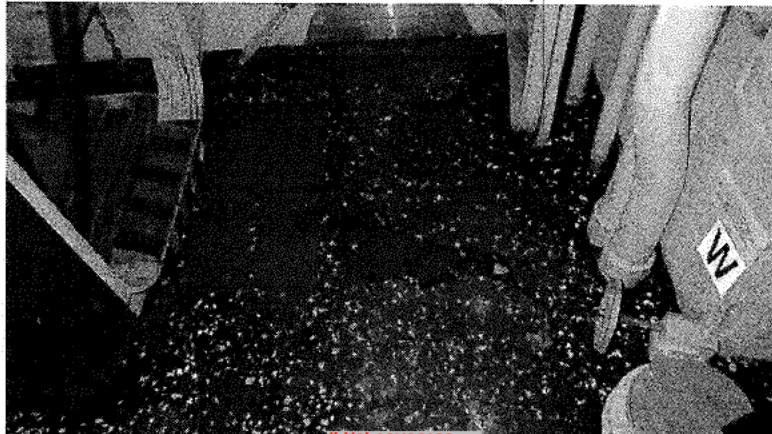
04 level impact was primarily limited to smoke and/or water damage, however the deck in the Pilot House (b)(3), 10 U.S.C. 130 directly above Passage (b)(3), 10 U.S.C. 130 exhibited heat damage from the fire below (Figure 34). (RESERVED FOR FUTURE ADDITIONAL CONTENT ABOUT DECK DAMAGE)

Figure 34 – Pilot House (b)(3),10USC130 Deck Coating Damage

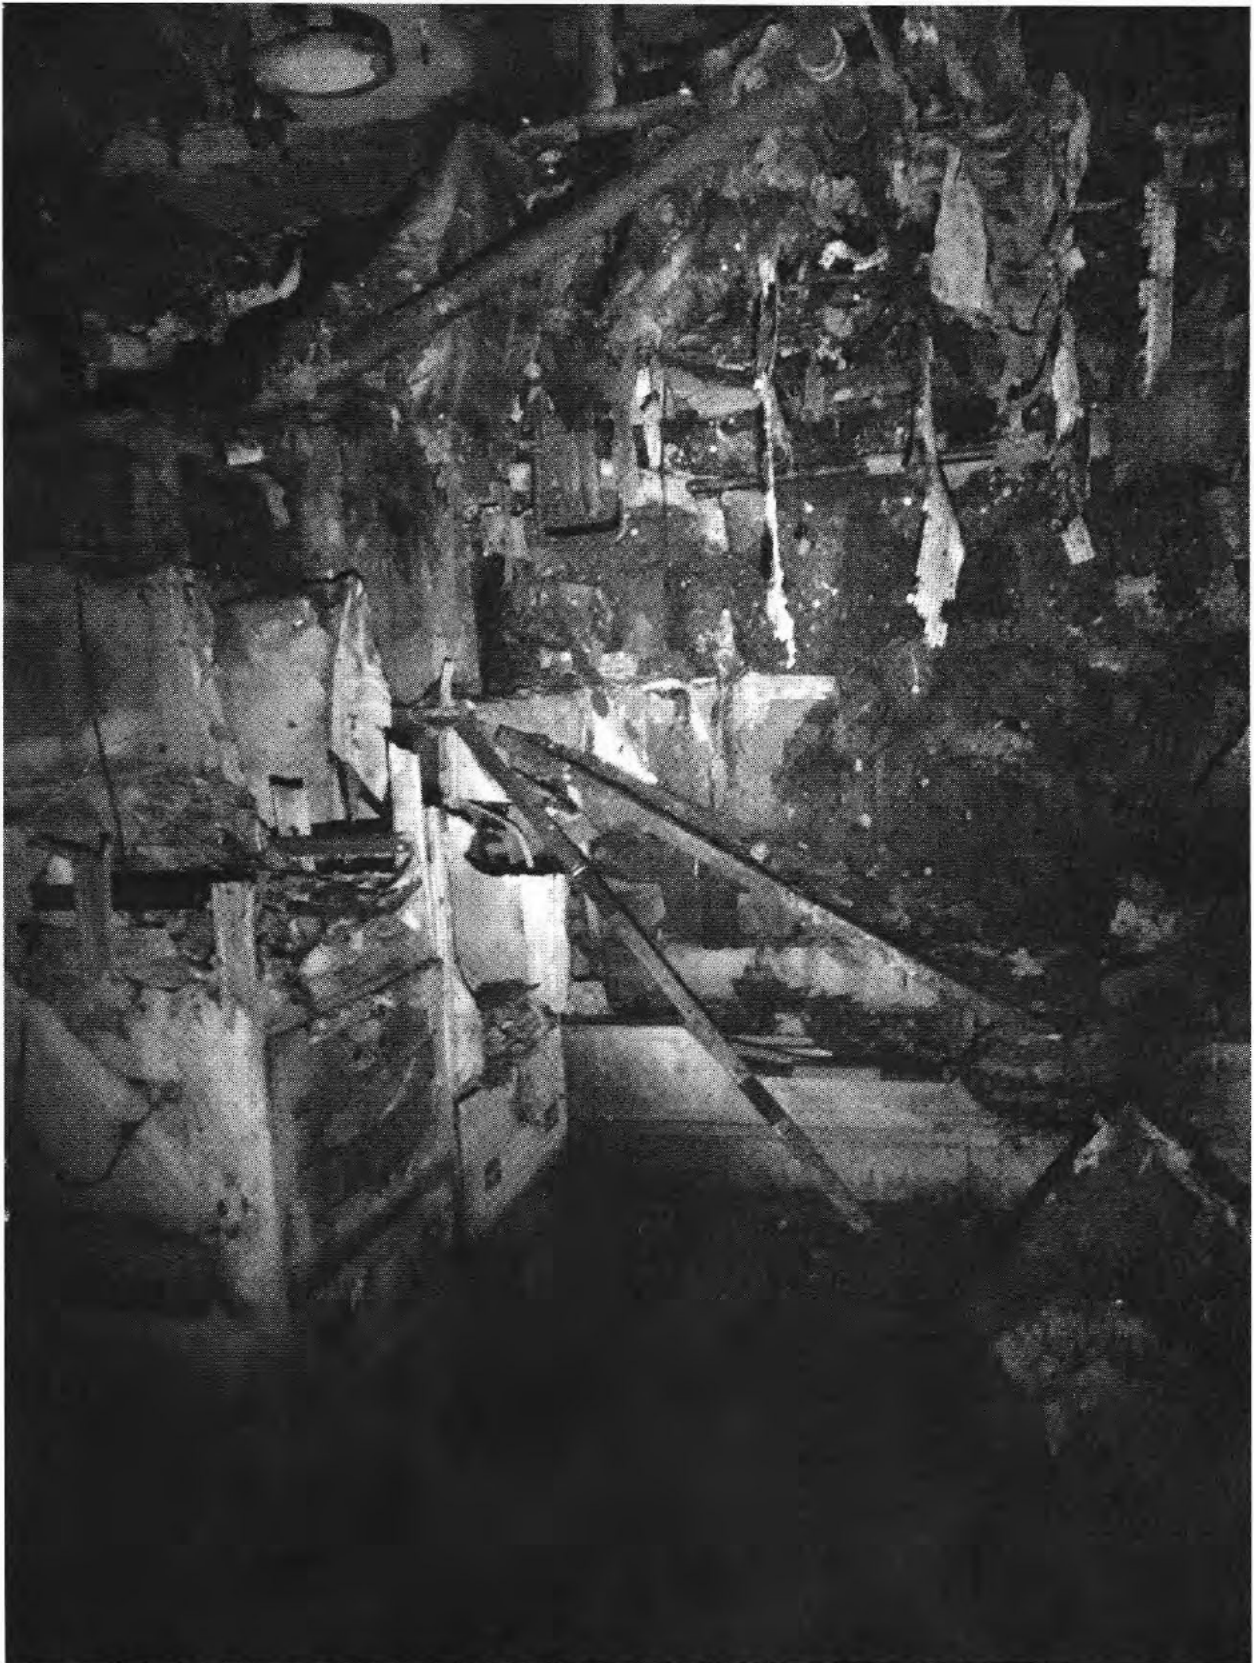
(b)(3),10USC130 (Stateroom) onboard USS OSCAR AUSTIN. The seat of the fire was at the top right hand corner of this picture.
